## Pump Action Assembly Note

**Model:** Escalade Pump Action Shotgun

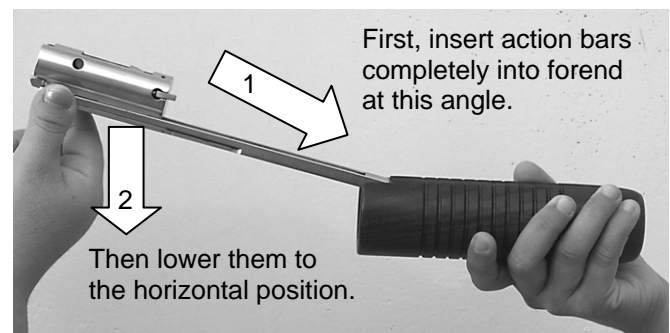
**Cause:** When assembling the forend to the action, the action bars are incorrectly connected to the forend. The action bars probably are Not fully nested into the inner metal sleeve of the forend.

1. Insert the action bars assembly into the forend at an angle as shown in the picture.
2. Lower the action bars to the horizontal position.
3. When supported only by the forend, the action bars should Not droop below the horizontal. If they droop, it means the action bars are Not correctly nested into the forend.
